Quality Assurance and Source Inspection

Contract #: 04-0120F4Cty: SF/ALA Rte: 80 PM: 13.2/13.9File #: 1.28**WELDING INSPECTION REPORT****Resident Engineer:**Siegenthaler, Peter**Address:** 333 Burma Road**City:** Oakland, CA 94607**Report No:** WIR-023451**Date Inspected:** 06-May-2011**Project Name:** SAS Superstructure**OSM Arrival Time:** 700**Prime Contractor:** American Bridge/Fluor Enterprises, a JV**OSM Departure Time:** 1530**Contractor:** American Bridge/Fluor Enterprises, a JV**Location:** Job Site**CWI Name:** See Report Below**CWI Present:** Yes No**Inspected CWI report:** Yes No N/A**Rod Oven in Use:** Yes No N/A**Electrode to specification:** Yes No N/A**Weld Procedures Followed:** Yes No N/A**Qualified Welders:** Yes No N/A**Verified Joint Fit-up:** Yes No N/A**Approved Drawings:** Yes No N/A**Approved WPS:** Yes No N/A**Delayed / Cancelled:** Yes No N/A**Bridge No:** 34-0006**Component:** Orthotropic Box Girders**Summary of Items Observed:**

WELDING INSPECTION REPORT

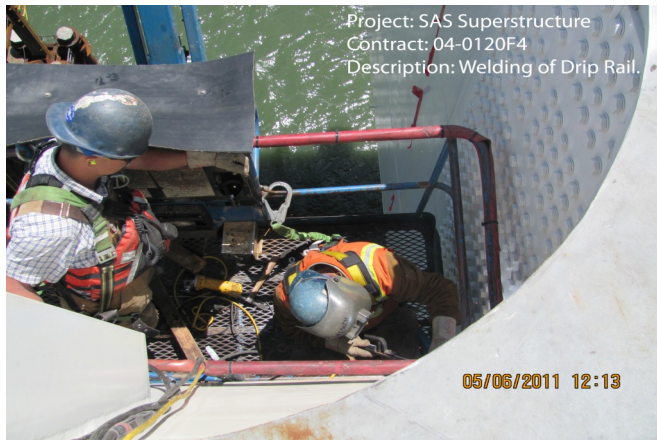
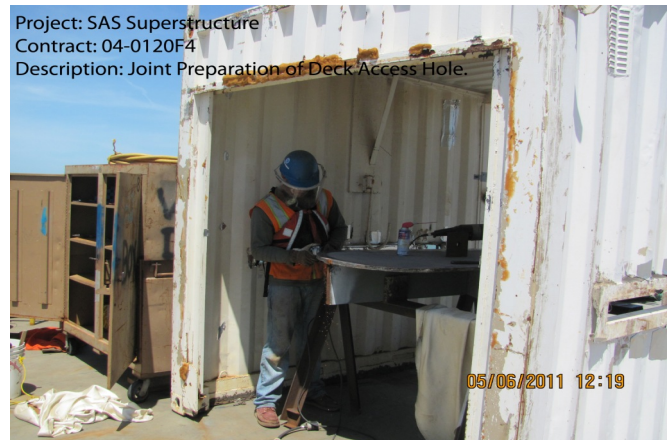
The QAI observed the CJP welding of the lifting lug holes identified as WN:8W-PP68-W3-W2 & W4, 7W-PP55-W4-W3 and 7E-PP56-E3-W3. The welding was performed by Darcel Jackson ID-9967, Mike Jiminez ID-4671 and Jason Collins ID-8128 utilizing the WPS's identified as ABF-WPS-D15-1050A-CU, Rev.0 and 1110A. The in process welding and the inspection performed by John Pagliero and Fred Von Hoff appeared to comply with the contract specifications.

The welding was performed in the flat (1G) and overhead (4G) positions utilizing the E7018-H4R low hydrogen electrodes. The 3.2 mm and the 4.0 mm electrodes were stored in electrically heated, thermostatically controlled oven after removal from the sealed containers. The exposure limits of the electrodes appeared to comply with the minimum storage oven temperature of 120 degrees Celsius as per the contract documents. The WPS's were also utilized by the QC inspectors as a reference to monitor the welding operation, verify the welding parameters and verify the minimum preheat and the interpass temperatures. The welding parameters and surface temperatures were verified by the QC inspector's utilizing a Fluke 337 clamp meter for the electrical welding parameters and Tempil Heat Indicators for verifying the preheat and interpass temperatures. At the time of the observation no issues were noted by the QAI.

The digital photographs below illustrates some of the related work activities observed during this scheduled shift.
